**FOCUSED SITE INSPECTION PRIORITIZATION
SITE EVALUATION REPORT**

**LIDLAW AVENUE LANDFILL
(ALSO KNOWN AS LIDLAW CITY DUMP)
935 LIDLAW AVENUE
CINCINNATI, HAMILTON COUNTY, OHIO**

EPA ID NO. OHD 000 810 176

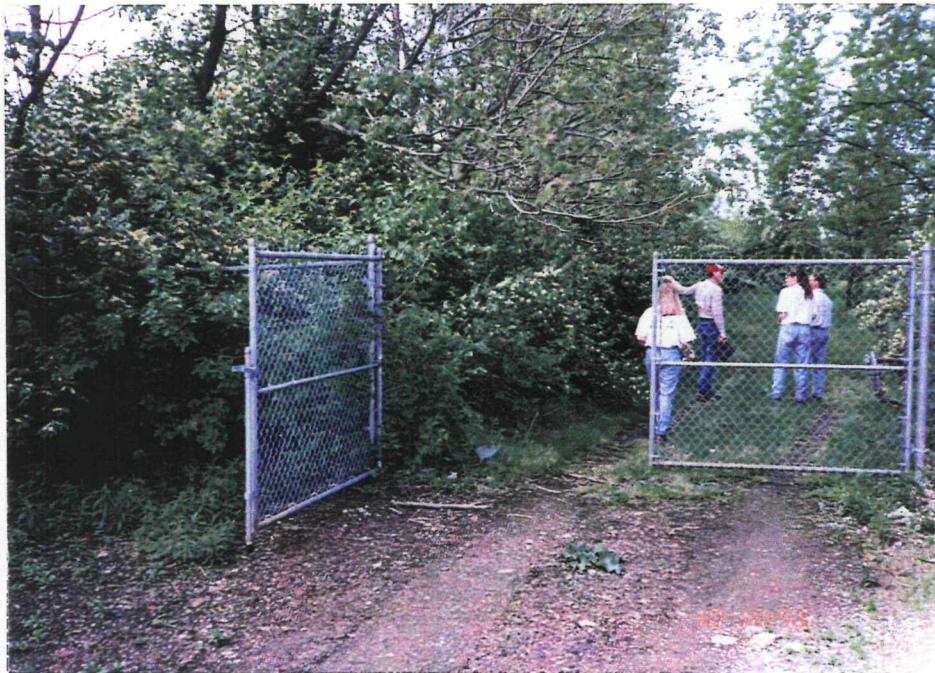
Photograph No. 1

Description: Entrance to landfill with gate in chain-link fence

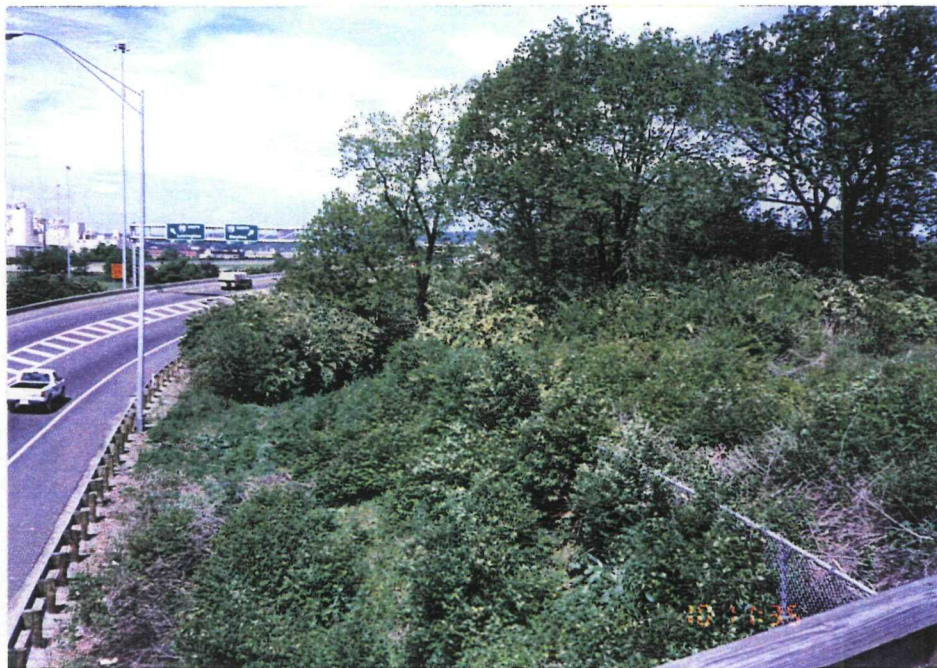
Photograph No. 2

Description: Southern landfill boundary with fence along State Route 562

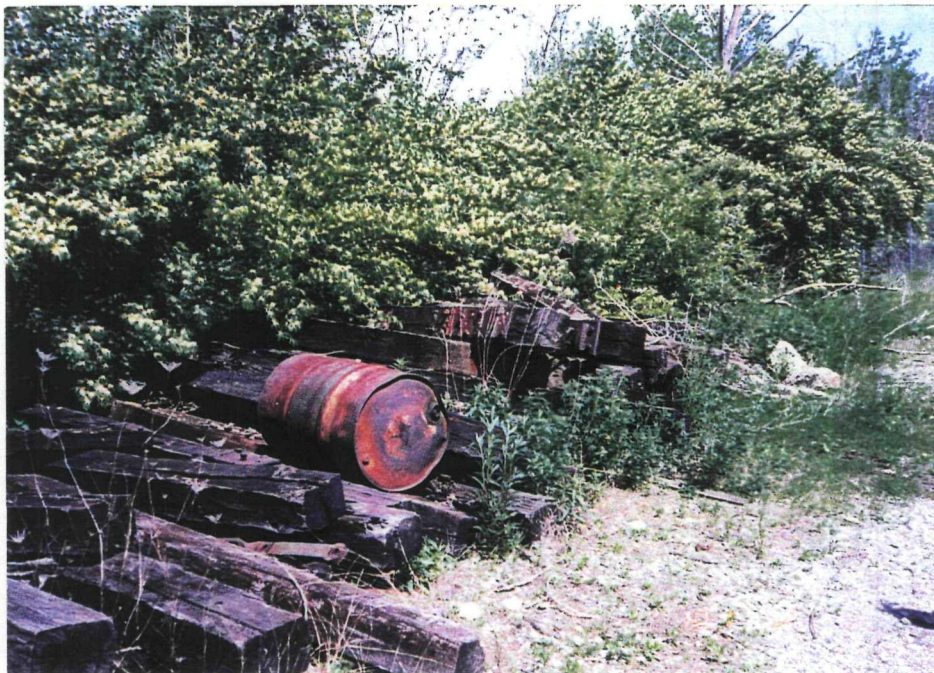
Photograph No. 3

Description: Waste reportedly from Norfolk & Western Railroad dumped along fence line of landfill

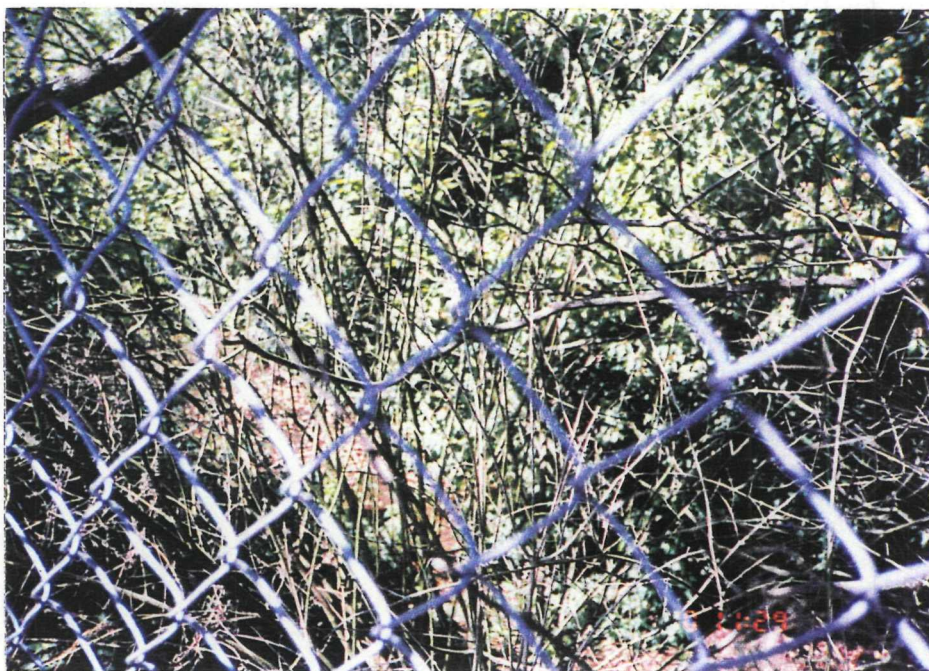
Photograph No. 4

Description: Drainage ditch with standing water

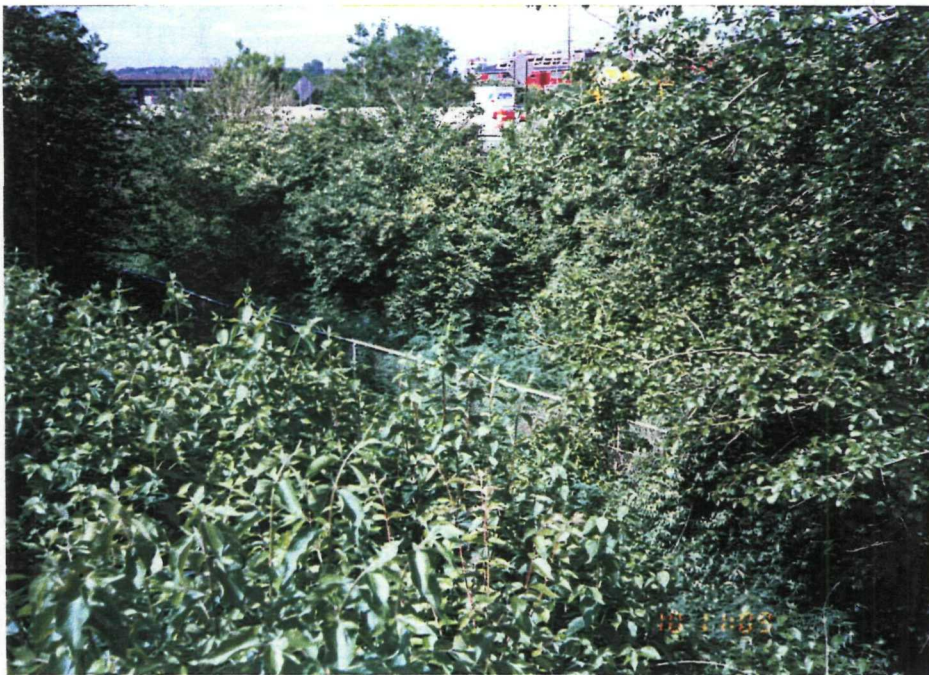
Photograph No. 5

Description: View of drainage ditch from the top of the landfill

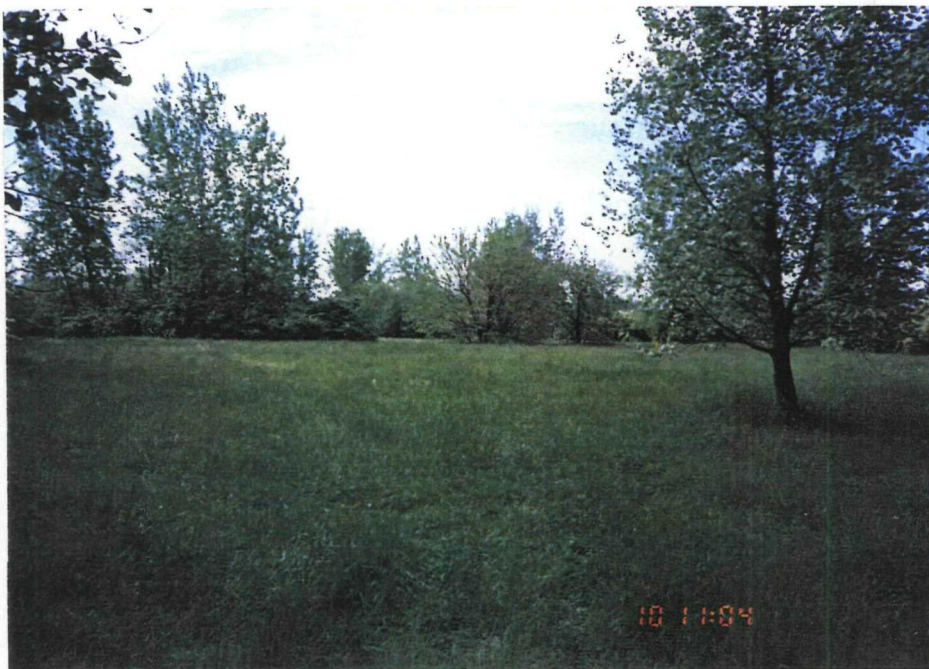
Photograph No. 6

Description: Cap of landfill, covered by well maintained vegetation

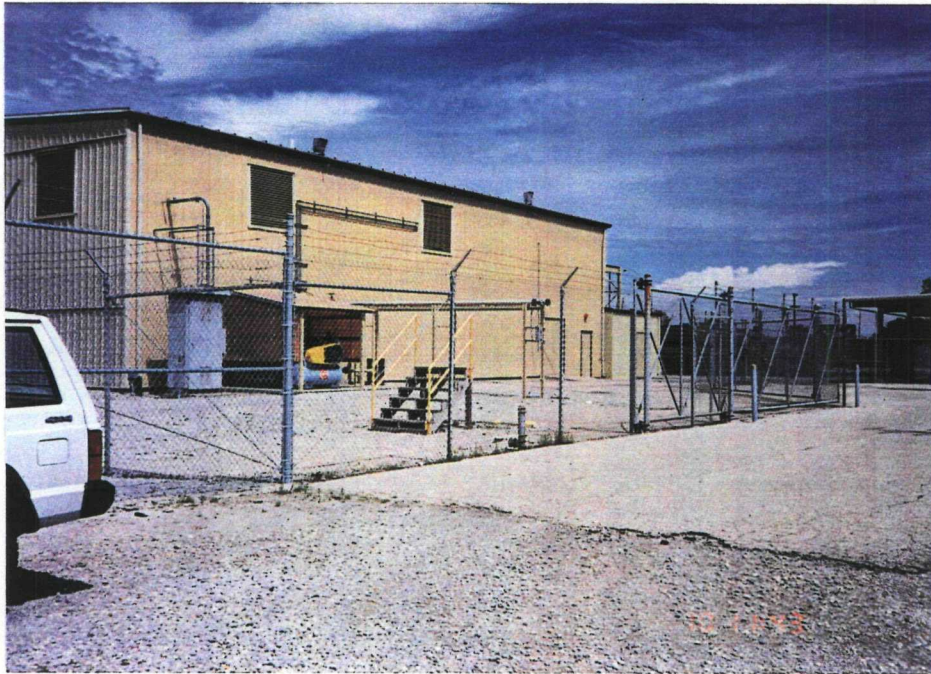
Photograph No. 7

The four on-site structures are surrounded by an 8-foot-high, chain-link fence topped with barbed wire (see Photograph No. 7). Access to these structures is restricted.

Description: Perfume manufacturing building, surrounded by chain-link fence with barbed wire
